Example of “Ductility” of Skidmark Geomembrane® irrigation ditch/canal lining

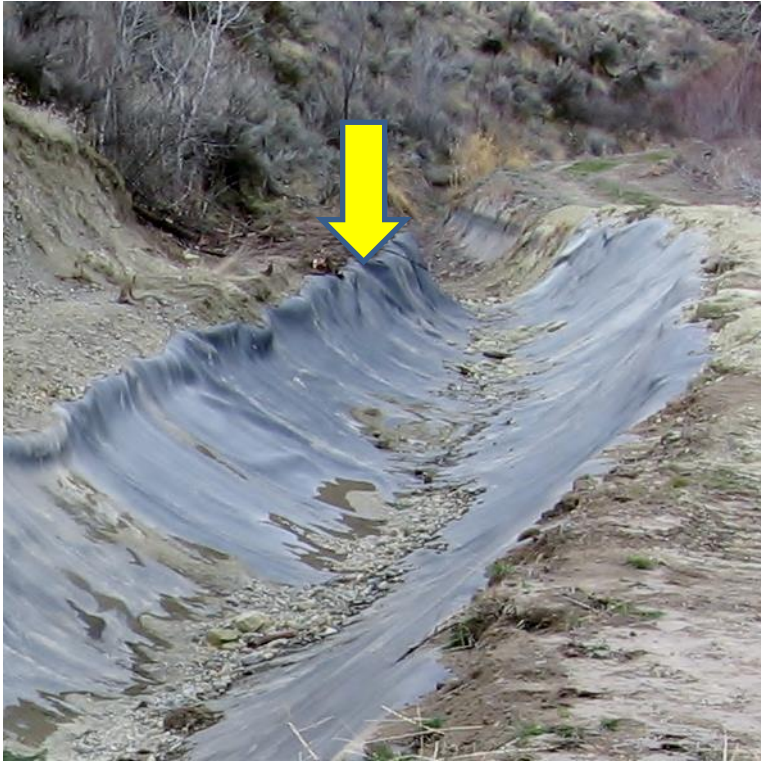
The top left photo shows liner after installation and before water on from downstream end. Right photo shows liner molded to ditch after second water season. Bottom photos are of the same area from the upstream end.

The liner in this installation was secured along the berms with rebar. Backside bank and narrow front side berm prevented the use of anchor trenches required by most liner suppliers. Further, the liner is performing well in this nearly half-pipe ditch profile with vertical sides.
